# **Connecticut Coastal Structures Inventory Study**

PHASE I - NEW LONDON COUNTY

APPENDIX C  
NEW LONDON QUADRANGLE  
RECORDS OF STRUCTURES WITH PHOTOGRAPHS

SEPTEMBER 1988

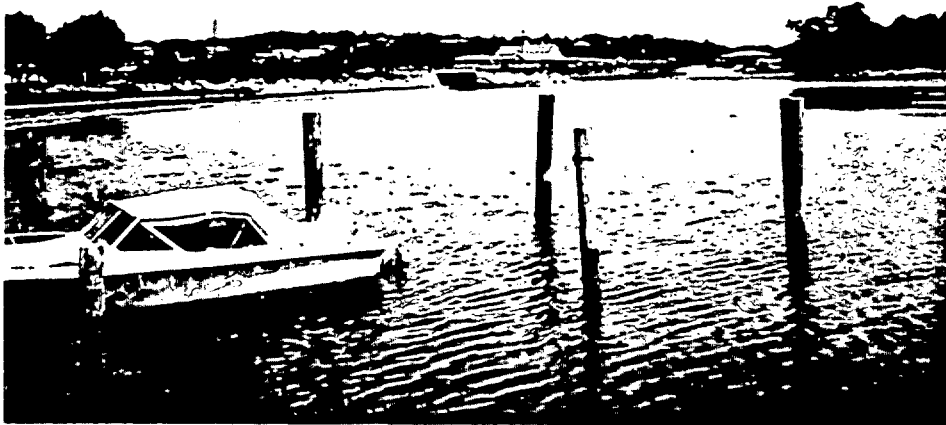
NL .1.CC #1

TYPE OF STRUCTURE: BRIDGE/REVTMEN                      CONDITION: GOOD  
MAIN FUNCTION : RETAIN SLOPE ALONG BRIDGE  
MATERIAL : LARGE BOULDERS

APROX L= 400 FT, H= 6 FT ABOVE MHW

#1 ROLL 12 NEG 12 PICTURE OF REVETMENT AND BRIDGE AT PALMER  
#2 COVE  
#3  
#4  
#5

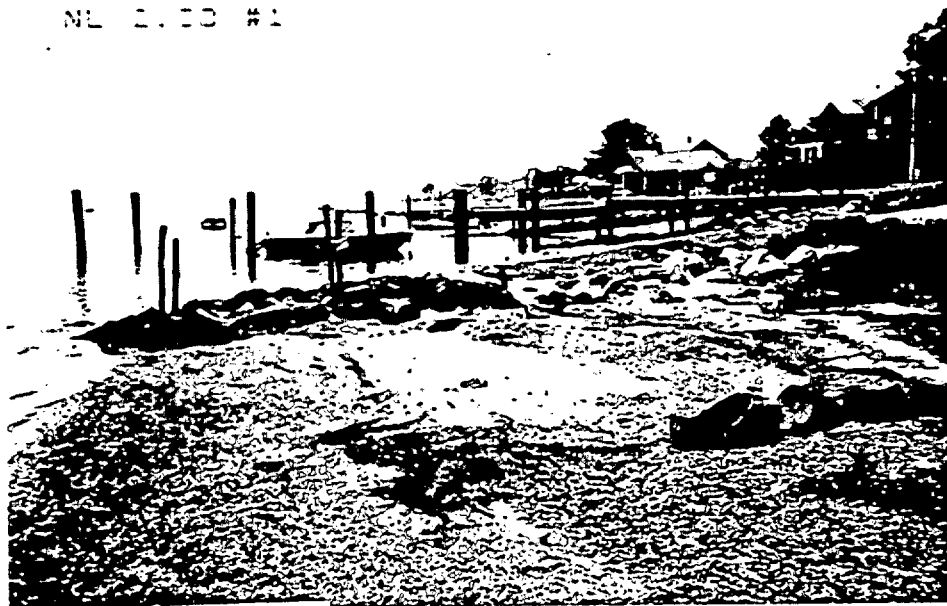
NL 2.00 #1

TYPE OF STRUCTURE: SMALL GROIN CONDITION: POOR  
MAIN FUNCTION : FORMERLY WAS DOCK FOUNDATION.  
MATERIAL : ROCKS

#1 ROLL 12 NEG 13 POOR ROCK GROIN  
#2 ROLL 12 NEG 14 ROCK GROIN  
#3 ROLL 12 NEG 15 SHOWS HOW NORTH SIDE HAS LESS SEDIMENT THAN  
#4 SOUTH SIDE  
#5

GOOD AMOUNT OF SEDIMENT BUILT UP.

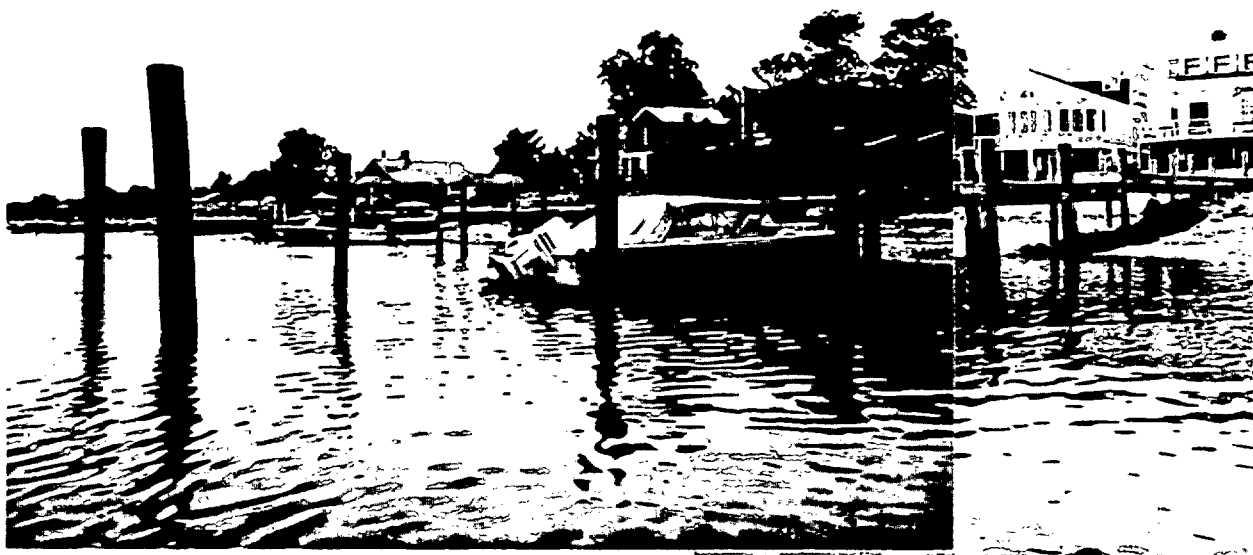
NL 3.00 #1

TYPE OF STRUCTURE: 4 GROIN SYSTEM CONDITION: FAIR-POOR  
MAIN FUNCTION : SEDIMENT TRAP AND PILE SUPPORT  
MATERIAL : 2 ROCK/2 CEMENT

#1 ROLL 12 NEG 16,17 LOOKING SOUTH ALONG GROIN SYSTEM  
#2 ROLL 12 NEG 18 SECOND GROIN, ROCK TYPE  
#3 ROLL 12 NEG 19 CEMENT TYPE GROIN  
#4  
#5

SEDIMENT TRANSPORT FROM SOUTH TO NORTH ON WEST SIDE OF  
PALMER COVE

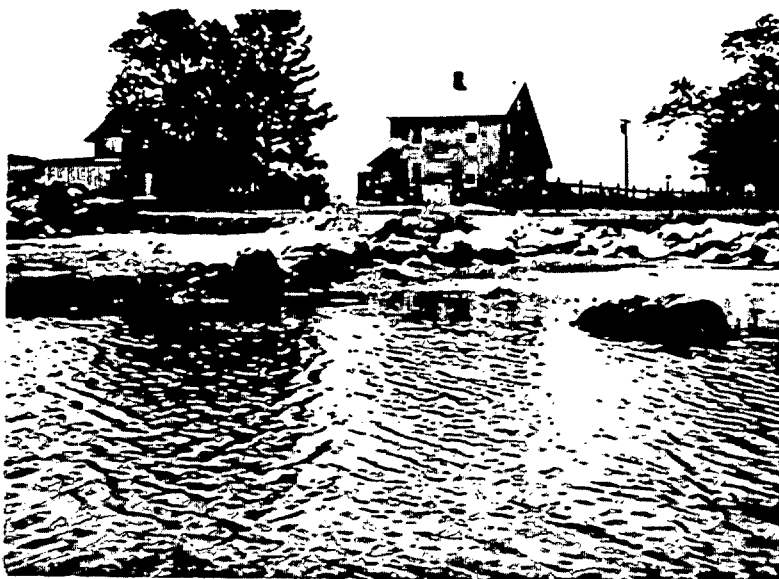
NL 4.00 #1

TYPE OF STRUCTURE: SEAWALL CONDITION: GOOD  
MAIN FUNCTION : SLOPE STABILIZATION  
MATERIAL : STONE IN CEMENT

#1 ROLL 12 20-22 SEAWALL AND GROINS  
#2  
#3  
#4  
#5

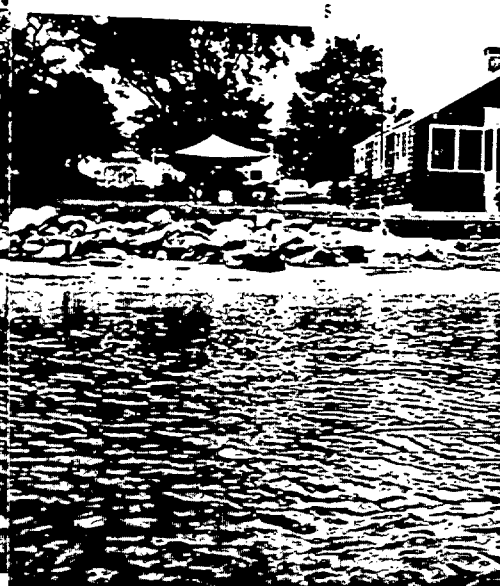
NL 4.10 #1

TYPE OF STRUCTURE: 2 GROINS CONDITION: POOR  
MAIN FUNCTION : SEDIMENT TRAP  
MATERIAL : LOOSE ROCKS

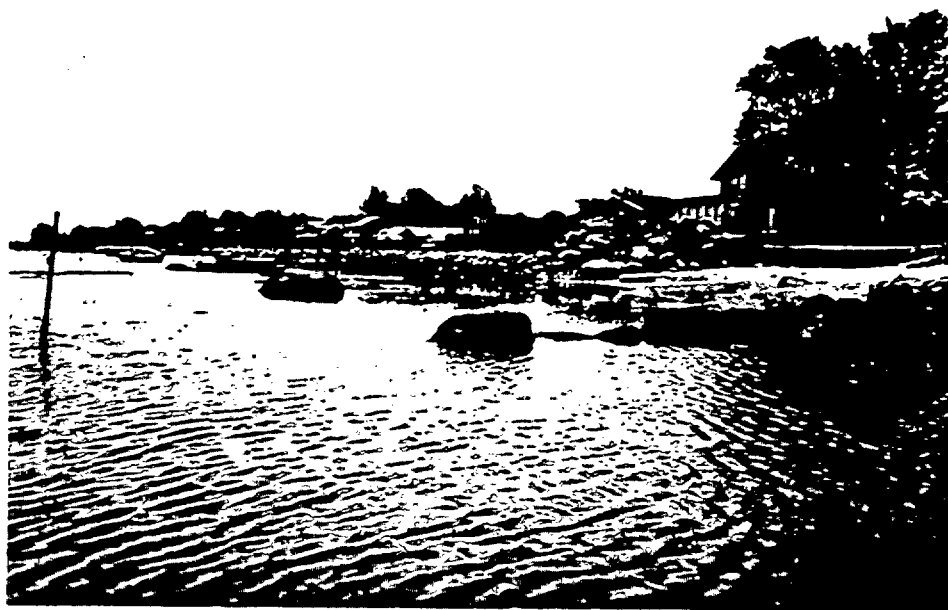
#1 ROLL 12 NEG 20-22 SEAWALL AND GROINS  
#2  
#3  
#4  
#5

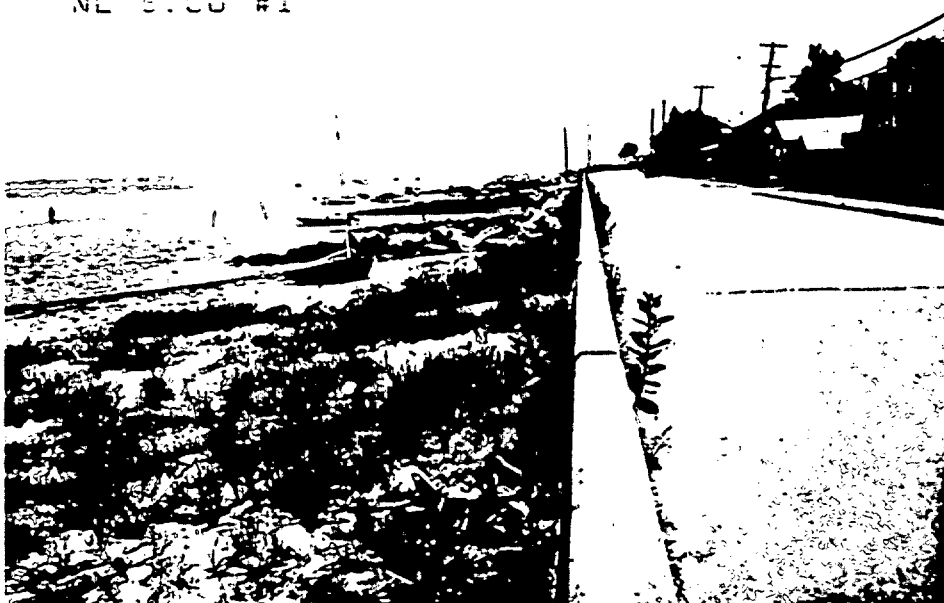
NL 5.00 #1

TYPE OF STRUCTURE: SEAWALL CONDITION: GOOD  
MAIN FUNCTION : PROTECT SHORE AGAINST HIGH WATER  
MATERIAL : CEMENT

#1 ROLL 12 NEG 23 NORTH LOOKING SOUTH  
#2 ROLL 12 NEG 24 SOUTH LOOKING NORTH  
#3  
#4  
#5

5 AND 5.1 ARE A SEAWALL/GROIN SYSTEM

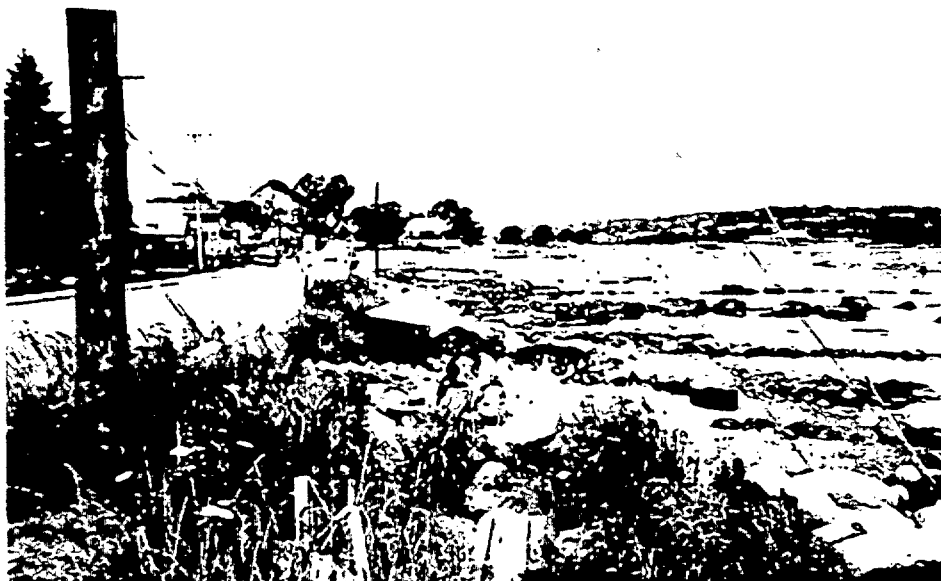
NL 5.00 #2

TYPE OF STRUCTURE: 2 GROINS                      CONDITION: POOR  
MAIN FUNCTION : MAINTAIN SANDY BEACH  
MATERIAL : LOOSE ROCKS

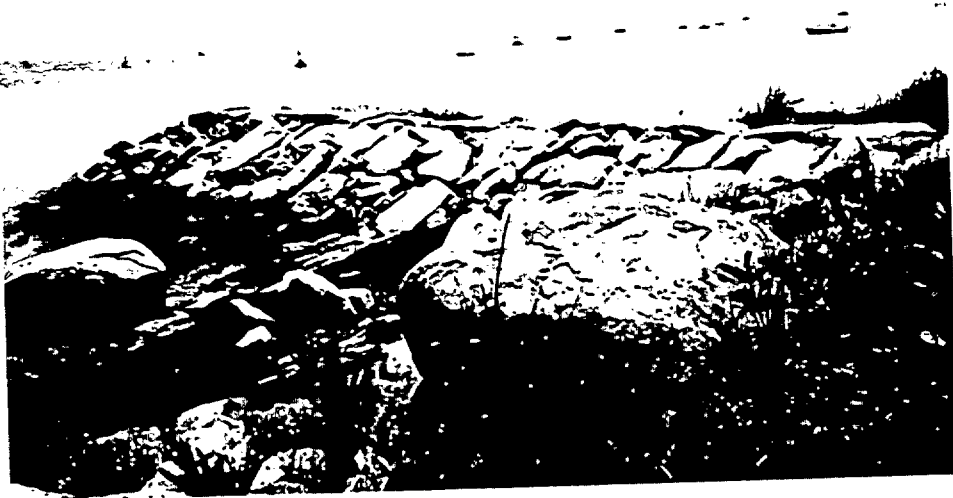
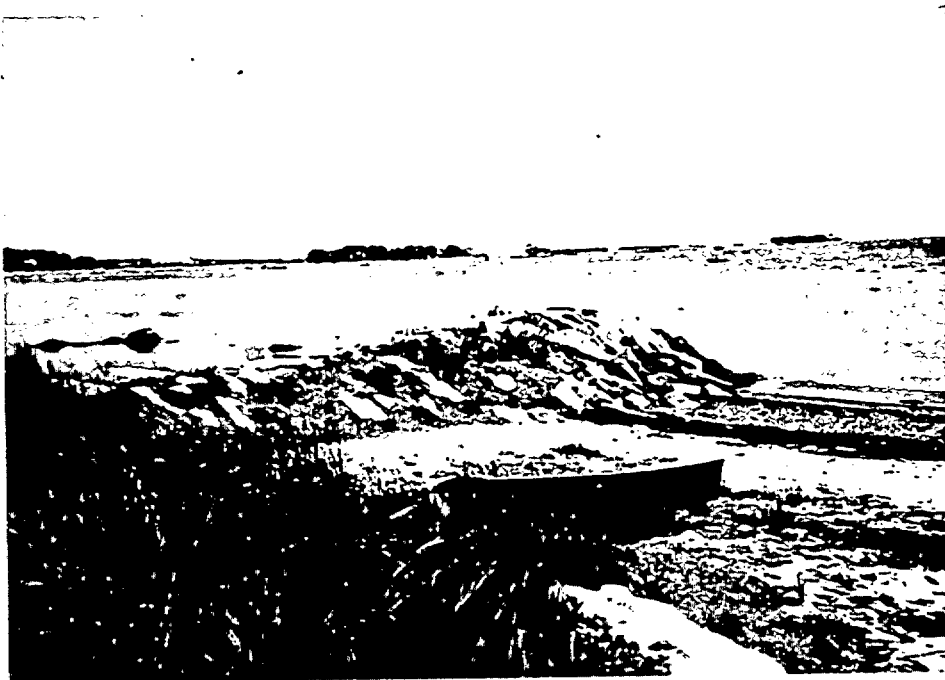
NL 6.00 #1

TYPE OF STRUCTURE: GROIN CONDITION: GOOD  
MAIN FUNCTION : EROSION CONTROL AND SAND ENTRAPMENT  
MATERIAL : STONE/CAP ROCK

#1 ROLL 12 NEG 25,26 PICTURES OF GROIN  
#2  
#3  
#4  
#5

SANDY BEACH (SOME ROCKS) TO EITHER SIDE. EXCELLENT EXAMPLE  
OF GOOD CONSTRUCTION.

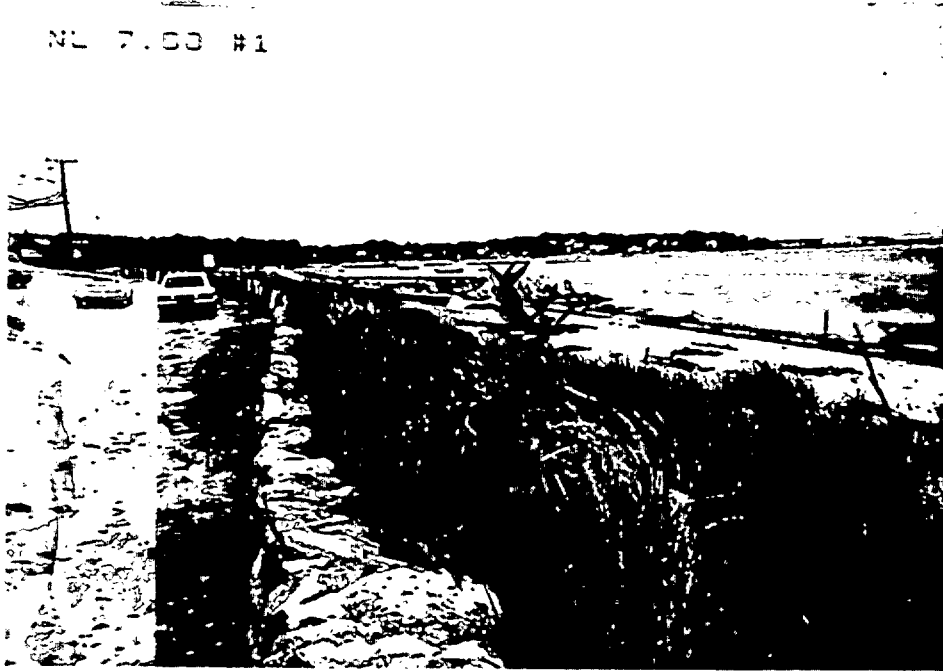
NL 7.00 #1

TYPE OF STRUCTURE: SEAWALL CONDITION: GOOD  
MAIN FUNCTION : PROTECT ROADWAY  
MATERIAL : ROCKS IN CEMENT

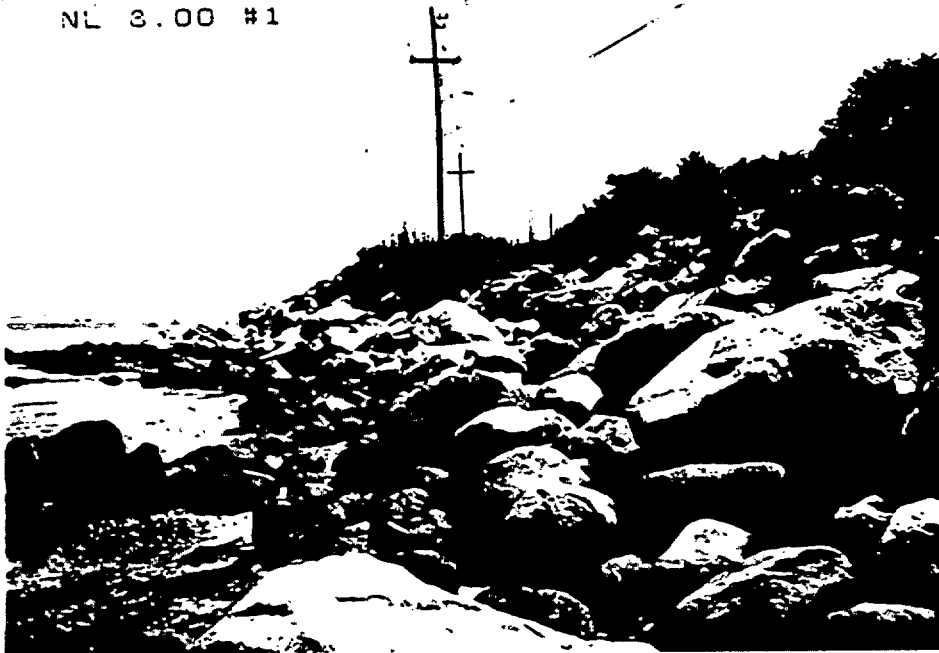
NL 8.00 #1

TYPE OF STRUCTURE: RIPRAP CONDITION: GOOD  
MAIN FUNCTION : SHORE STABILIZATION  
MATERIAL : ROCKS

#1 ROLL 13 NEG 3 ROCK REVETMENT LOOKING SOUTH  
#2 ROLL 13 NEG 4 ROCK REVETMENT LOOKING NORTH  
#3 ROLL 13 NEG 5 PLAMER COVE LOOKING NORTH FROM LONG POINT  
#4  
#5

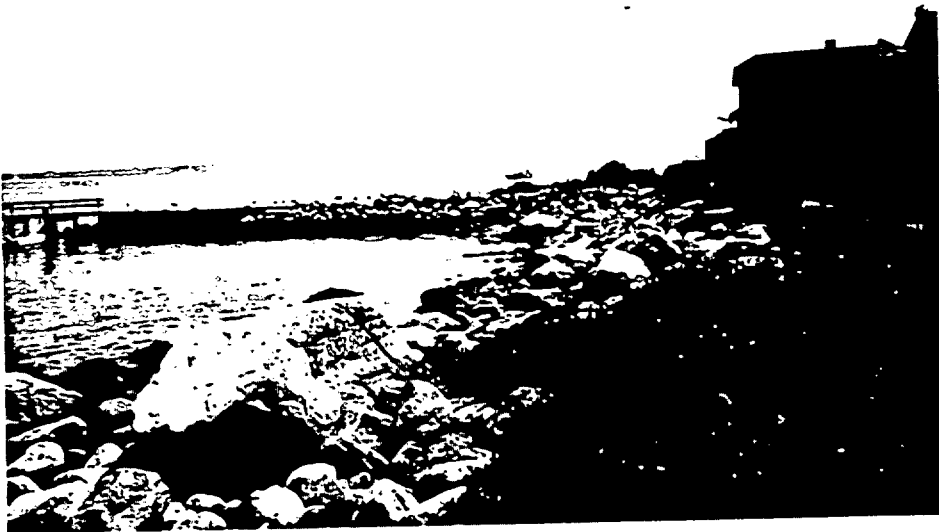
NL 9.00 #1

TYPE OF STRUCTURE: BULKHEAD & DOCK                      CONDITION: GOOD  
MAIN FUNCTION : SUPPORT FOR DOCK  
MATERIAL : STONE IN CEMENT

#1      ROLL 13 NEG 6 LOOKING SOUTH TO STRUCTURE  
#2      ROLL 13 NEG 7 LOOKING NORTH TO STRUCTURE  
#3  
#4  
#5

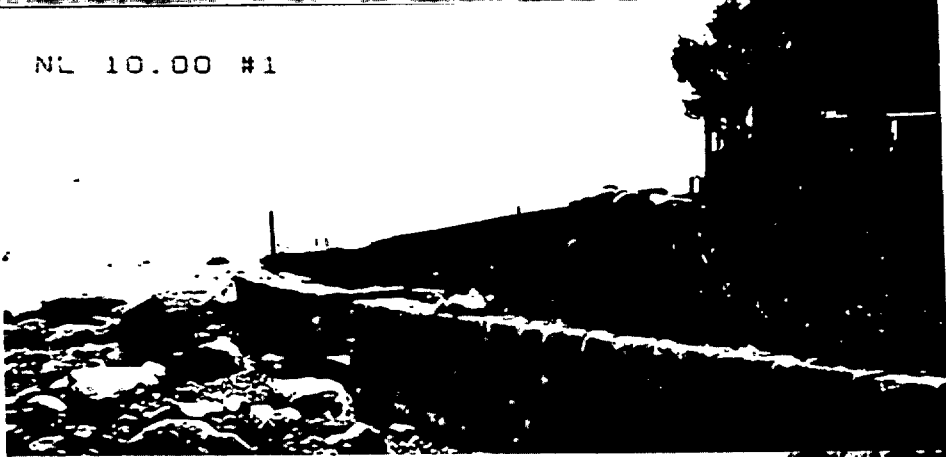
NL 10.00 #1

TYPE OF STRUCTURE: SEAWALL CONDITION: GOOD  
MAIN FUNCTION : SUPPORT OF SLOPE AND EROSION PROTECTION  
MATERIAL : STONE IN CEMENT

RUBBLE AND BOULDERS CAST ON SHORE. SEAWALL EXTENDS AROUND  
GROTON LONG POINT

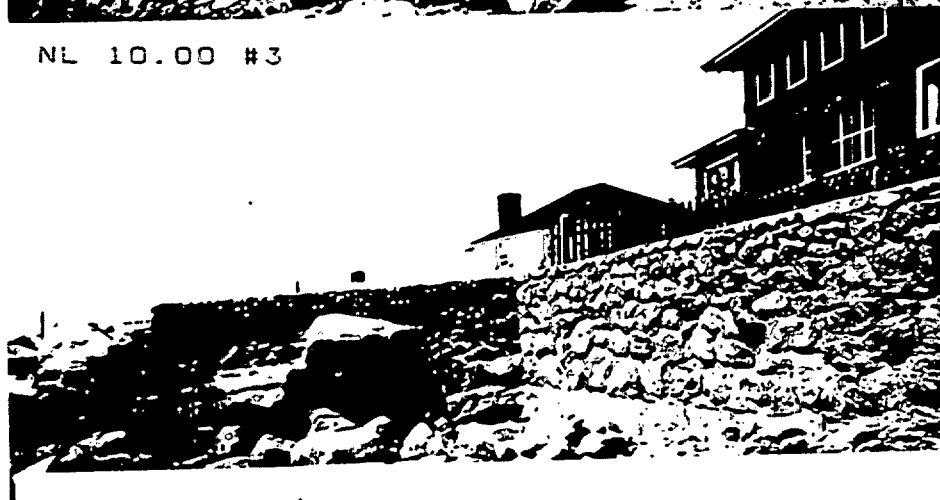
NL 10.00 #3

#1 ROLL 13 NEG 8 PICTURE OF SEAWALL EAST SIDE  
#2 ROLL 13 NEG 9 PICTURE OF SEAWALL  
#3 ROLL 13 NEG 10 PICTURE OF SEAWALL WEST SIDE  
#4 ROLL 13 NEG 11 END OF SEAWALL AND SANDY PORTION OF BEACH  
#5

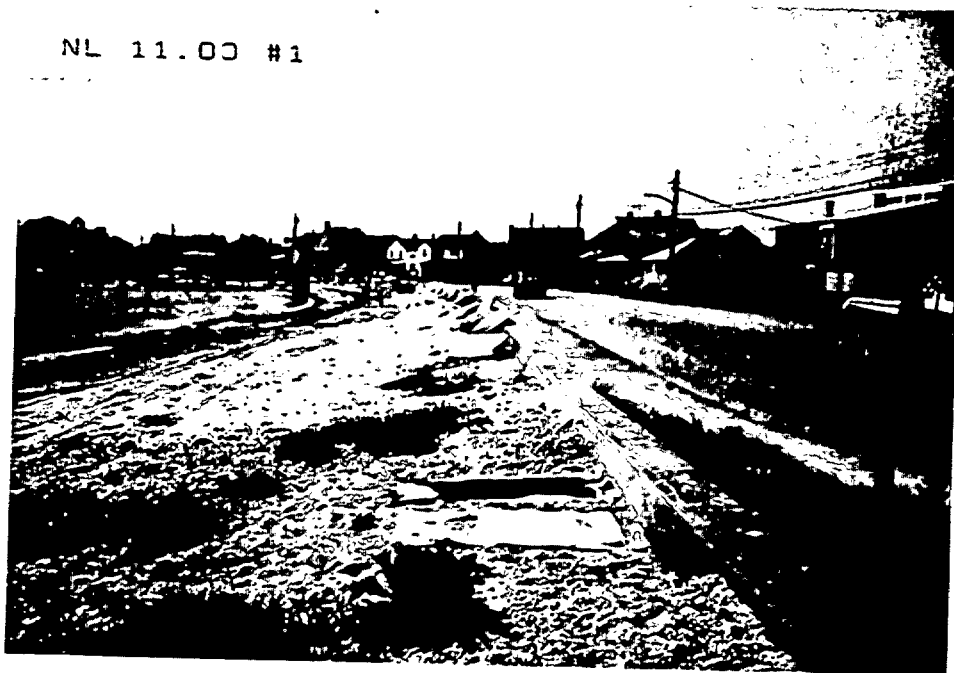
NL 11.03 #1

TYPE OF STRUCTURE: SEAWALL CONDITION: GOOD  
MAIN FUNCTION : PROTECTION OF ROADWAY  
MATERIAL : CONCRETE

#1 ROLL 13 NEG 12 SEAWALL FROM ROAD  
#2  
#3  
#4  
#5

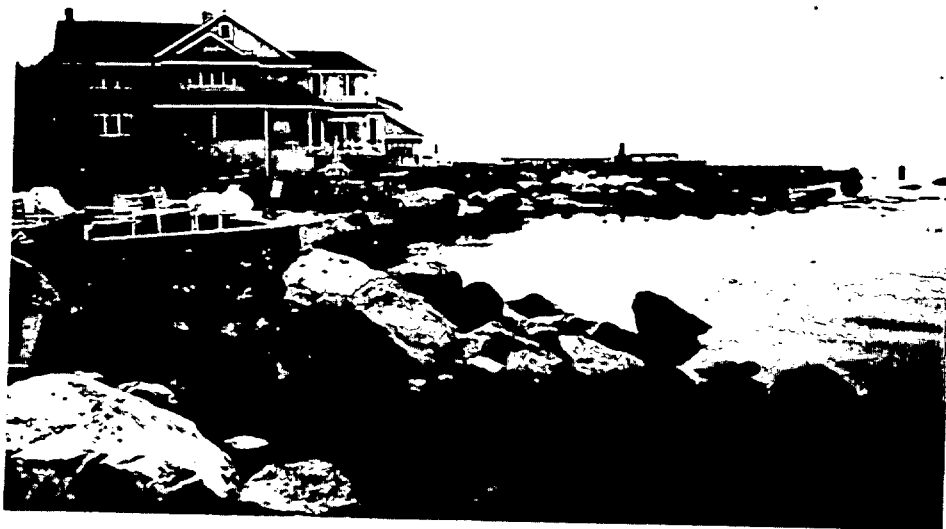
NL 13.00 #1

TYPE OF STRUCTURE: SEAWALL CONDITION: GOOD  
MAIN FUNCTION : SUPPORT LAND AND PROTECT FROM EROSION  
MATERIAL : STONE IN CEMENT

SANDY/ROCKY SHORE. SIZE AND SPACING OF STONES VARIED FROM LOT TO LOT.

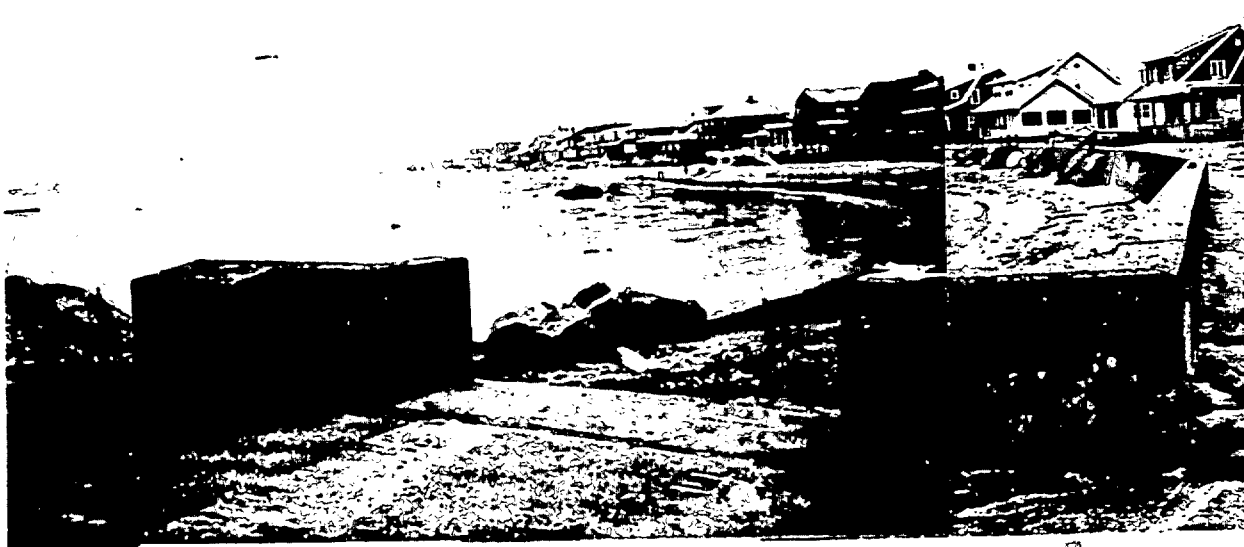
NL 14.00 #1

TYPE OF STRUCTURE: SEAWALL CONDITION: GOOD  
MAIN FUNCTION : STABILIZE SHORE AND PROVIDE STORM PROTECTION  
MATERIAL : CONCRETE

SEAWALL EXTENDS THE ENTIRE LENGTH OF THE BEACH TO THE POINT  
WHERE PRIVATE RESIDENCE IS LOCATED NEAR B.M.7. HOMES ARE  
ALIGNED ONLY 20 FT BEHIND SEAWALL FOR ENTIRE BEACH

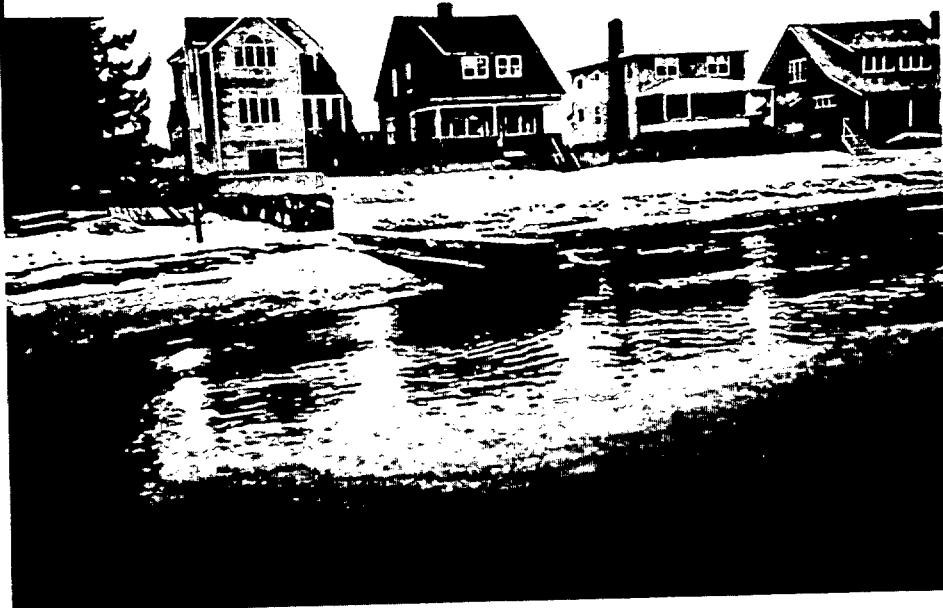
.NL 15.00 #1

TYPE OF STRUCTURE: GROIN CONDITION: GOOD  
MAIN FUNCTION : SAND RETAINMENT  
MATERIAL : CONCRETE

AREA IS ACCRETING SAND

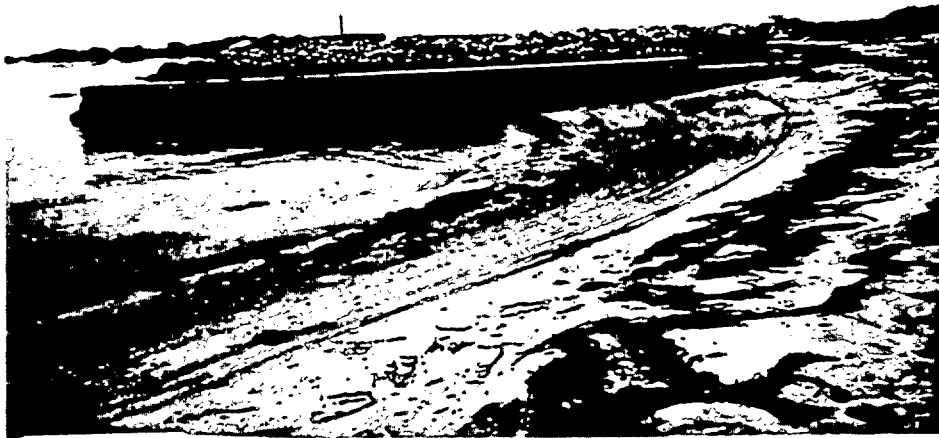
NL 16.00 #1

TYPE OF STRUCTURE: GROIN CONDITION: FAIR  
MAIN FUNCTION : TO RETAIN OWNER'S PRIVATE BEACH  
MATERIAL : ROCK/CEMENT CAP

ACCRETING

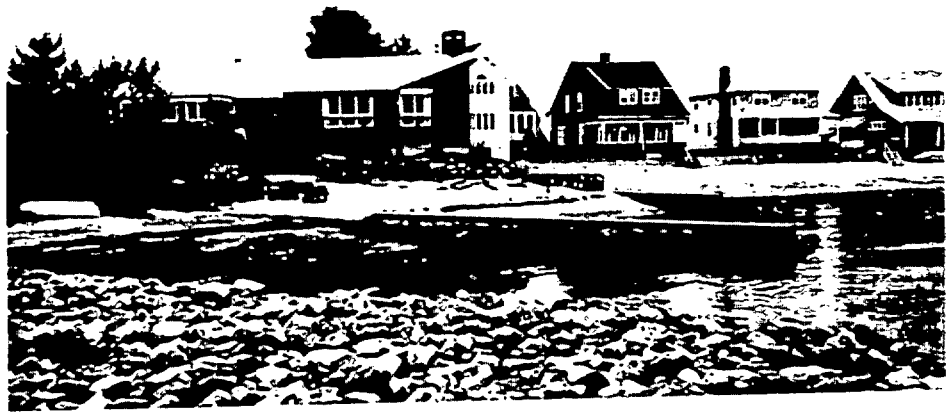
NL 17.00 #1

TYPE OF STRUCTURE: SEAWALL CONDITION: FAIR  
MAIN FUNCTION : PROTECTION OF RESIDENCE AGAINST WAVE ACTION  
MATERIAL : CONCRETE BLOCKS

DAMAGE - 4 BLOCKS HAVE BEEN TOPPLED. ROCKY AREA.

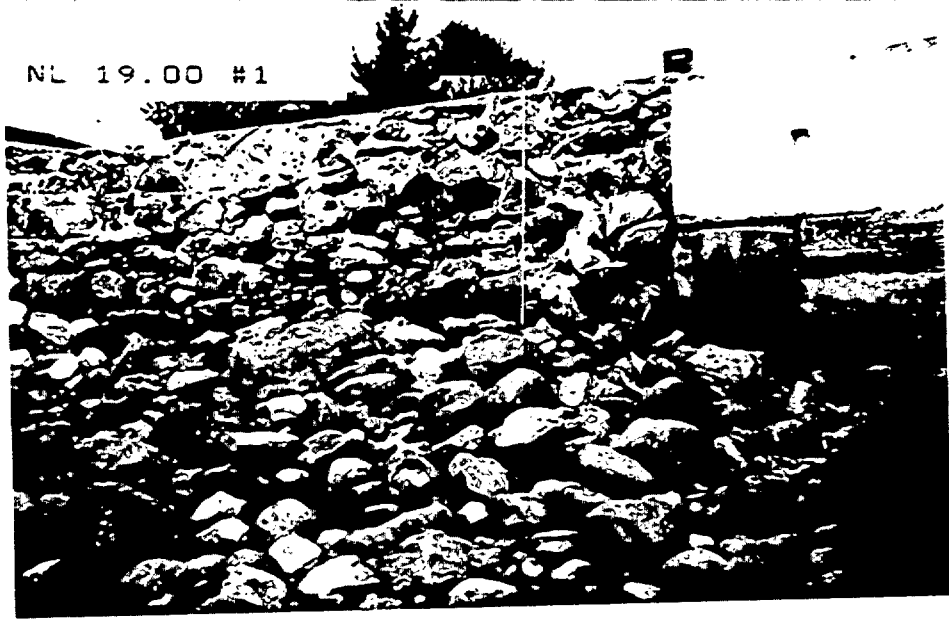
NL 19.00 #1

TYPE OF STRUCTURE: SEAWALL CONDITION: GOOD  
MAIN FUNCTION : SUPPORT SLOPE AND PREVENT EROSION  
MATERIAL : ROCKS IN CEMENT

STRUCTURE LOCATED NEAR ENTRANCE TO VENETIAN HARBOR. ALL  
AREA IS ROCKY WITH SOME COBBLES IN BETWEEN THE TWO GROINS.

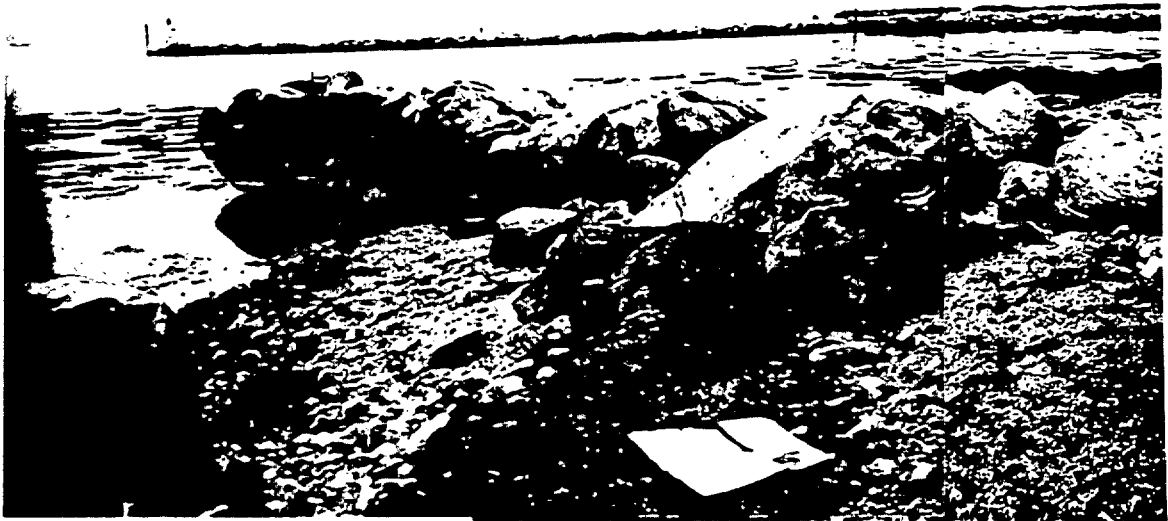
NL 20.00 #1

TYPE OF STRUCTURE: GROIN CONDITION: FAIR  
MAIN FUNCTION : POSSIBLY WAS DOCK FOUNDATION, NOW ACTS AS A GROIN  
MATERIAL : ROCKS

BEACH BETWEEN GROINS IS ROCKY COBBLES WITH SOME SAND. 45 FT  
BETWEEN GROINS.

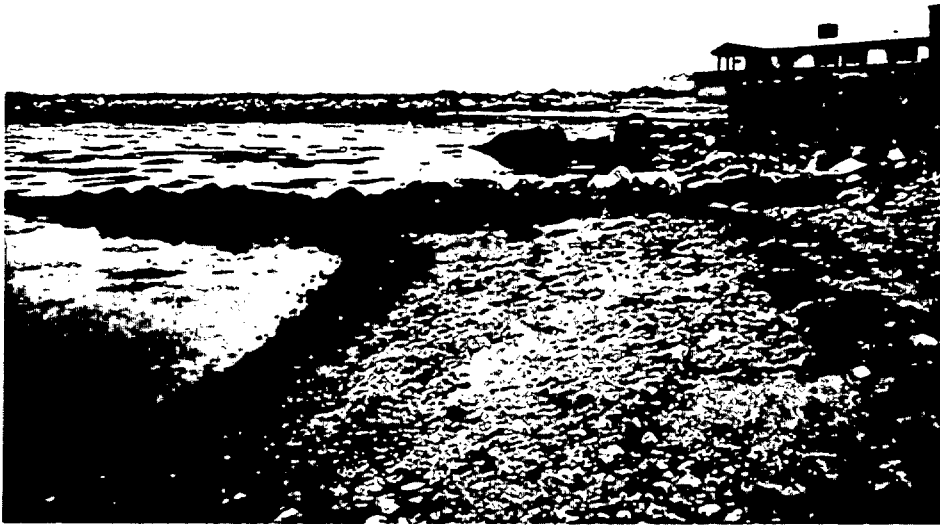
NL 21.00 #1

TYPE OF STRUCTURE: GROIN CONDITION: FAIR  
MAIN FUNCTION : POSSIBLY RESTRICTING ACCRETION ON OPPOSITE SIDE  
MATERIAL : ROCKS

VERY SMALL GROIN

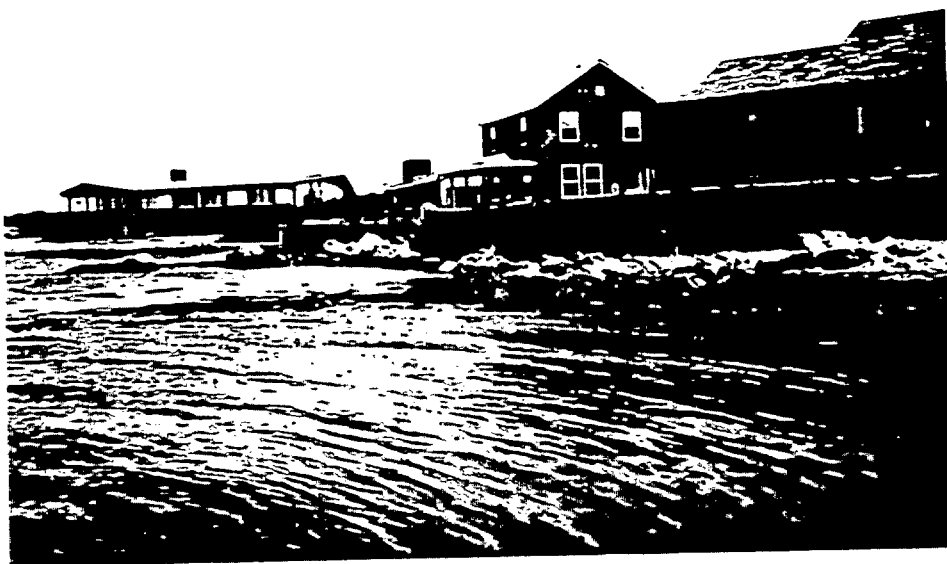
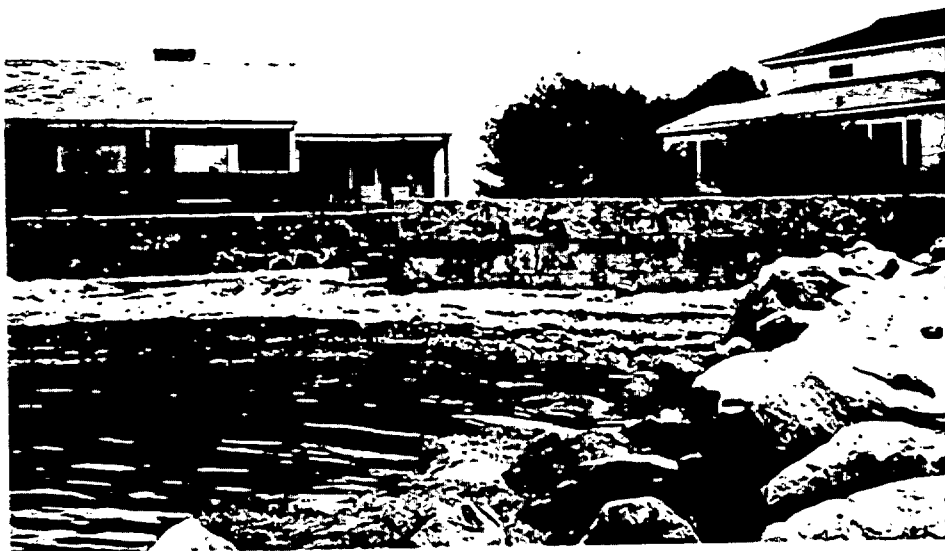
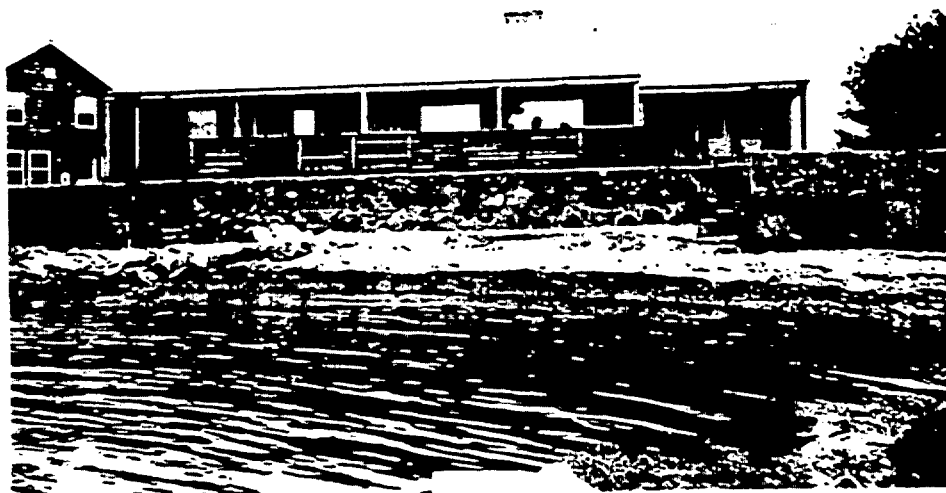
TYPE OF STRUCTURE: SEAWALL & GROIN CONDITION: GOOD  
MAIN FUNCTION : MAINTAINS AND RETAINS PRIVATE LOT  
MATERIAL : STONE IN CEMENT

#1 ROLL 15 NEG 16-18 SEAWALL WITH SMALL ROCK GROIN IN FRONT  
#2  
#3  
#4  
#5

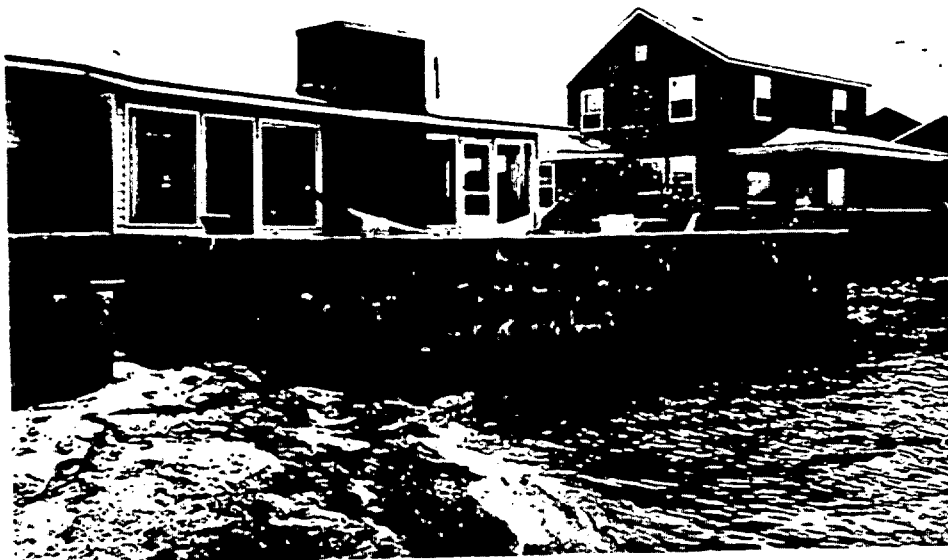
NL 23.00 #1

TYPE OF STRUCTURE: SEAWALL CONDITION: POOR  
MAIN FUNCTION : RETAINS PRIVATE LOT  
MATERIAL : STONE IN CEMENT

SMALL BEACH RETAINED IN FRONT OF WALL. ONE END OF WALL IS  
FALLING APART.

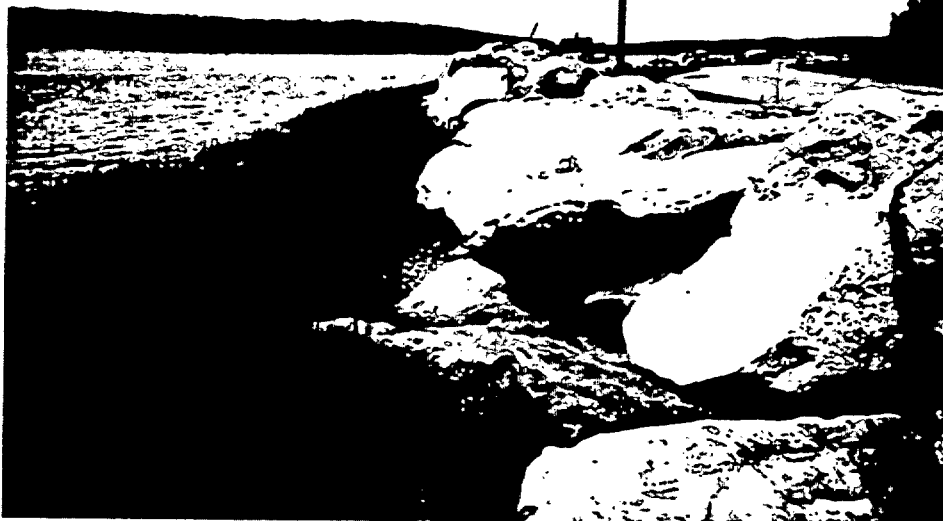
NL 26.00 #1

TYPE OF STRUCTURE: RIPRAP CONDITION: GOOD  
MAIN FUNCTION : HALTS EROSION FROM UNDER ISLAND CIRCLE ROAD  
MATERIAL : LARGE STONES

SHORELINE TO EITHER SIDE OF STRUCTURE IS GRASSY MARSH WITH  
NO STRUCTURES

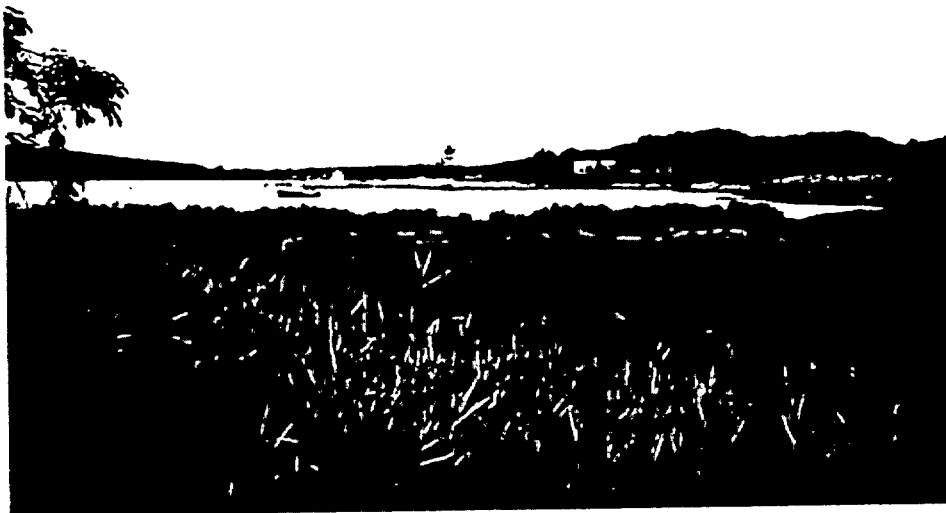
NL 27.00 #1

TYPE OF STRUCTURE: REVETMENT CONDITION: GOOD  
MAIN FUNCTION : HALTS EROSION OF MARSHY AREA BEHIND REVETMENT  
MATERIAL : STONES

MARSH TO SOUTH AND SANDY BEACH TO NORTH

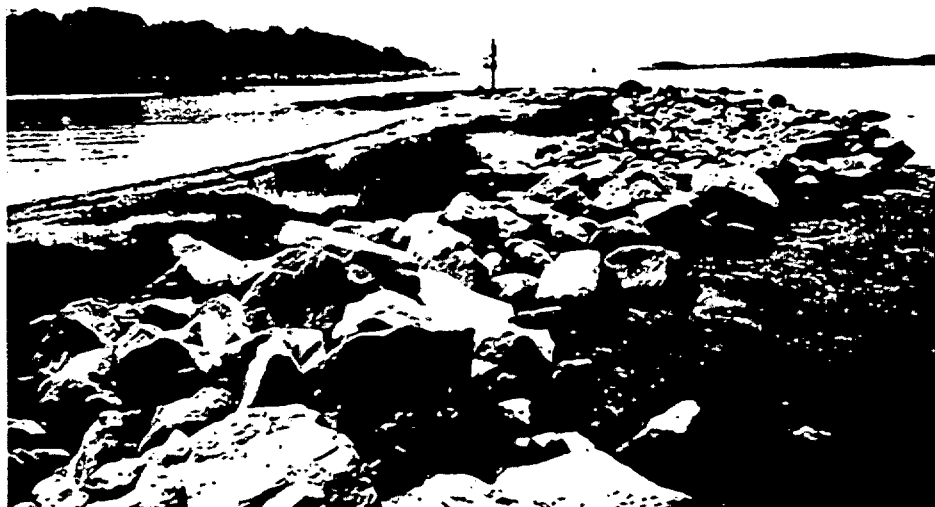
NL 28.00 #1

TYPE OF STRUCTURE: RIPRAP CONDITION: GOOD  
MAIN FUNCTION : PREVENT EROSION  
MATERIAL : STONE

JUPITER POINT-SAND ON EAST, RIPRAP ON WEST. BUSHY POINT HAS BEEN BREACHED BY 1938? HURRICANE. PART OF PINE ISLAND MAY FLOOD DURING STORM.

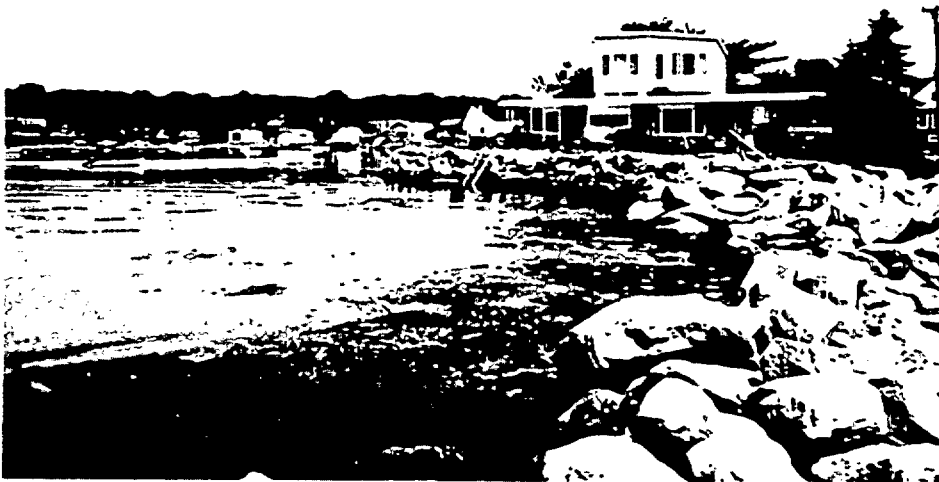
NL 23.10 #1

TYPE OF STRUCTURE: SEAWALL CONDITION: GOOD  
MAIN FUNCTION : RETAINS PRIVATE LOT  
MATERIAL : CONCRETE&STONES

LARGE WHITE STONES ON SOUTH SIDE, CONCRETE ON NORTH END.  
SHORELINE LINED WITH SEAWALLS.

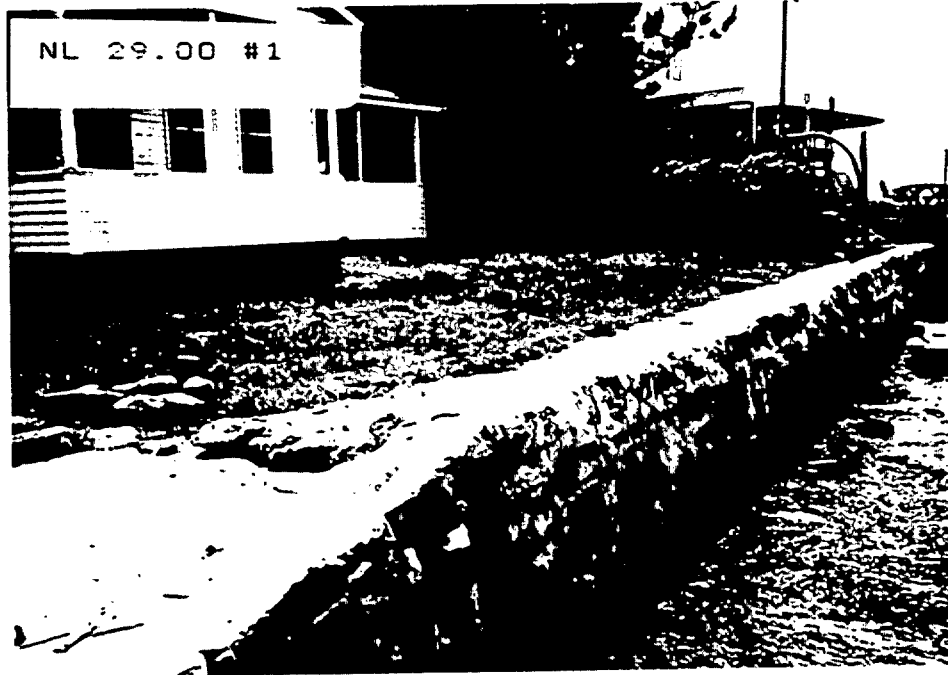
TYPE OF STRUCTURE: SEAWALL CONDITION: GOOD  
MAIN FUNCTION : RETAINS PRIVATE LOT, HALTS EROSION  
MATERIAL : STONE IN CEMENT

SHORELINE LINED WITH WALLS AND BULKHEADS

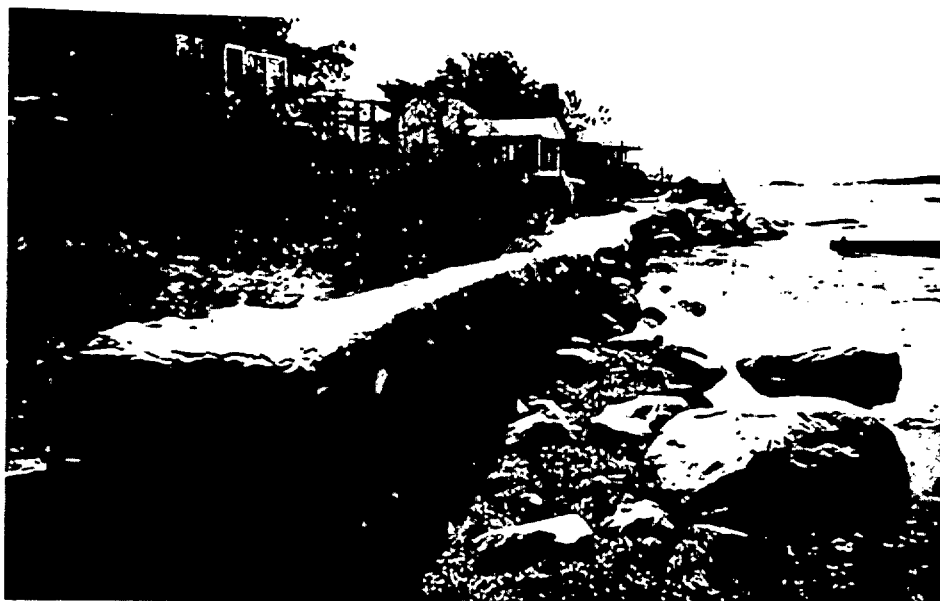
NL 30.00 #1

TYPE OF STRUCTURE: SEAWALL CONDITION: GOOD  
MAIN FUNCTION : RETAINS PRIVATE LOT  
MATERIAL : STONE IN CEMENT

EVIDENCE OF BACK SCOUR FROM OVERLAPPING WAVES. SHORE LINED  
WITH SEAWALLS AND RIPRAP.

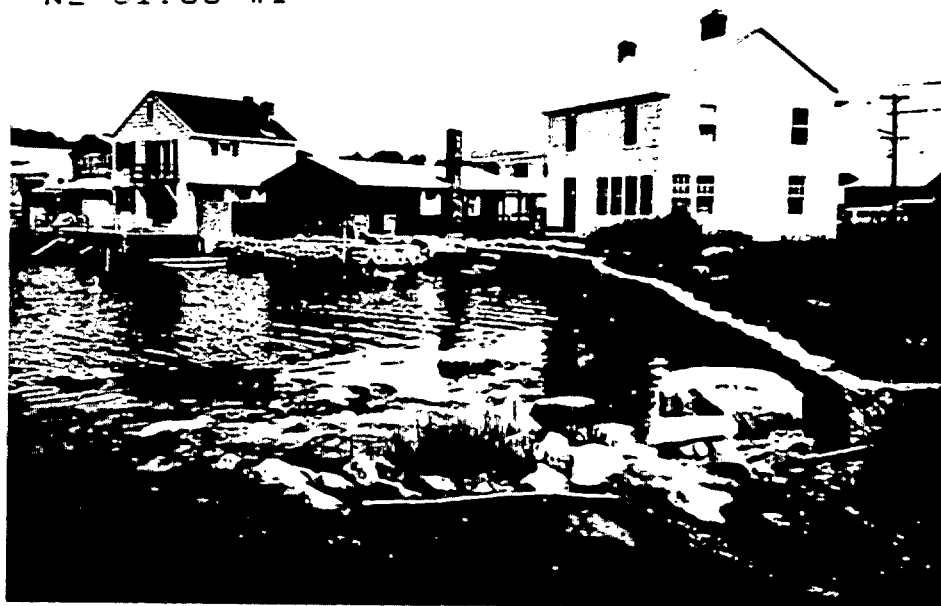
NL 31.00 #1

TYPE OF STRUCTURE: SEAWALL CONDITION: POOR  
MAIN FUNCTION : RETAIN PROPERTY IN FRONT OF 2 HOUSES  
MATERIAL : STONE IN CEMENT

#1 ROLL 16 NEG 12 SEAWALL FROM ADJOINING PROPERTY LOOKING NORTH  
#2 ROLL 16 NEG 13 DAMAGED SECTION OF SEAWALL  
#3  
#4  
#5

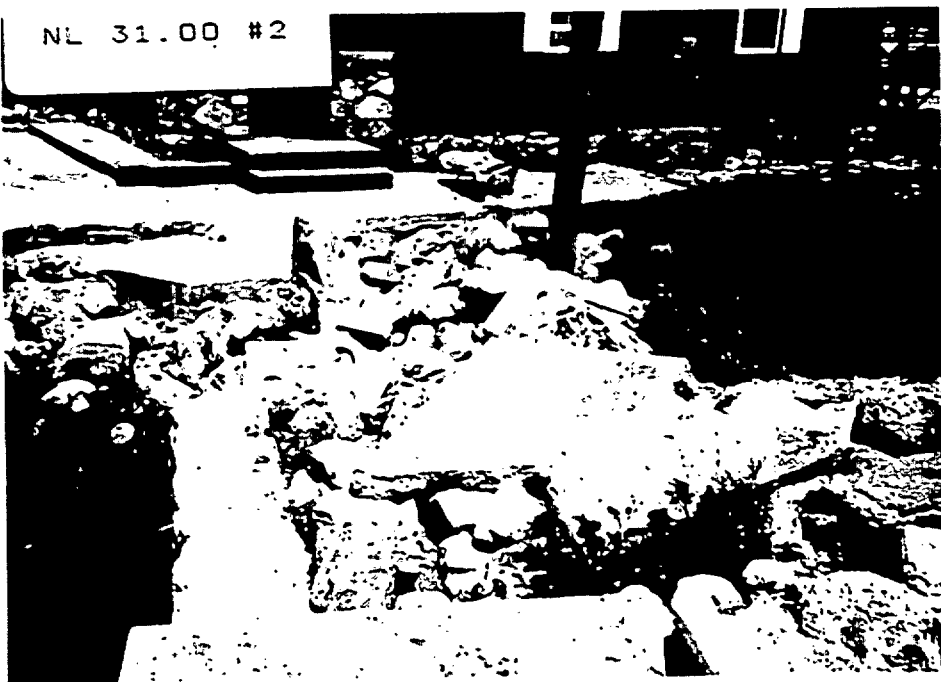
NL 31.00 #2

STRUCTURE ALSO AT 103 PINE ISLAND ROAD. SECTION OF WALL  
BETWEEN HOUSES DAMAGED BY STORMS. SHORE LINED WITH RIPRAP,  
SEAWALLS, AND REVETMENTS.

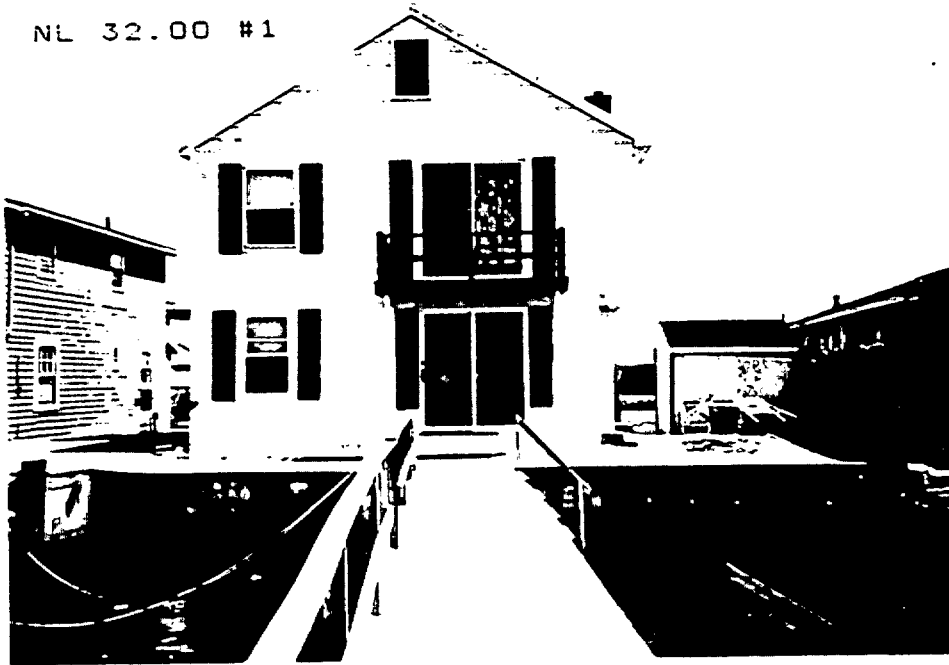
NL 32.00 #1

TYPE OF STRUCTURE: SEAWALL/DECKING CONDITION: GOOD  
MAIN FUNCTION : STOPS HOME (5 FT FROM EDGE) FROM FALLING INTO WATER  
MATERIAL : CEMENT

SEAWALL TOPPED BY CEMENT DECKING. SHORELINE COMPLETELY  
LINED WITH STRUCTURES.

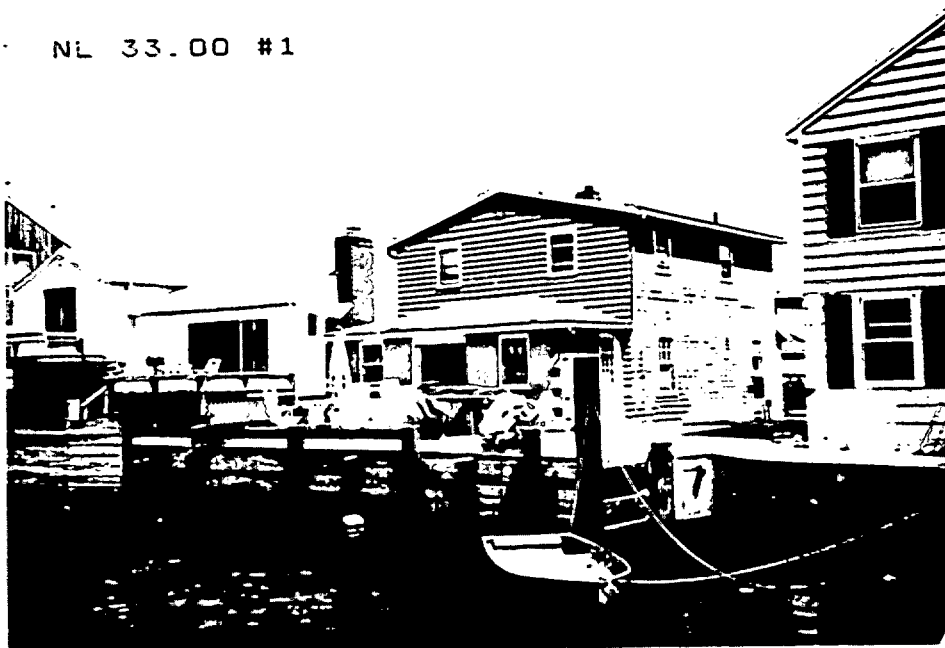
NL 33.00 #1

TYPE OF STRUCTURE: SEAWALL CONDITION: GOOD  
MAIN FUNCTION : HALTS EROSION OF PRIVATE LOT  
MATERIAL : STONE, CONCRETE

SHORELINE ALMOST COMPLETELY LINED WITH PROTECTIVE STRUCTURES
